SIGAR 14-13 Inspection Report

**Forward Operating Base Sharana: Poor Planning
and Construction Resulted in \$5.4 Million Spent
for Inoperable Incinerators and Continued Use of
Open-Air Burn Pits**

**DECEMBER
2013**

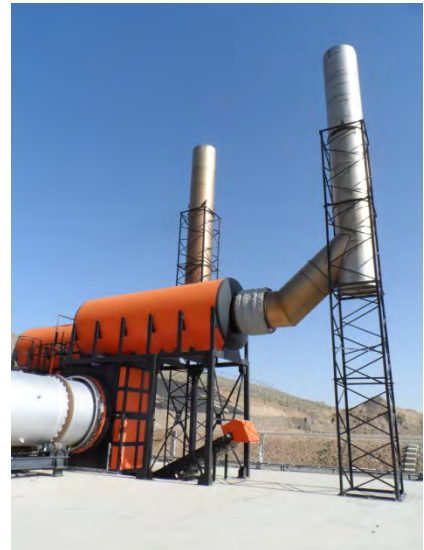
Our site inspection on May 20, 2013, found that the two incinerators installed at the site were not in operation. As a result, we could not fully assess the extent to which the facility met technical specifications. However, we were able to determine that (1) the project experienced significant construction delays; (2) the facility had electrical supply problems that could pose safety hazards; and (3) the incinerators, if made operational, could only be used by manually loading and unloading waste and would be limited to about 80 percent of the capacity called for under the original contract. Photo 1 shows the two incinerators at FOB Sharana.

Photo 1 - Two 40-Ton Capacity Incinerators at FOB Sharana

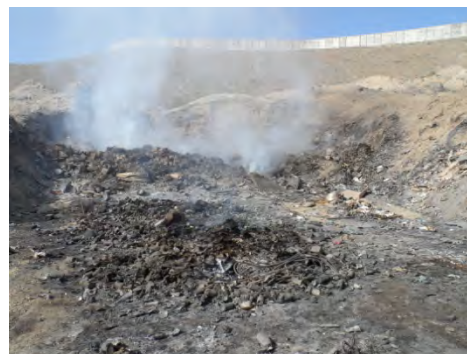
burn pits. Since the regulation's establishment in 2011, FOB Sharana had been using open-air burn pits in violation of the CENTCOM regulation. Photo 3 shows the open air burn pits and emissions at FOB Sharana.

Photo 3 - Open-Air Burn Pit Emissions
